CURT LEE DAM

GENTRY COUNTY, MISSOURI

MO. 10664

**PHASE 1 INSPECTION REPORT
NATIONAL DAM SAFETY PROGRAM**

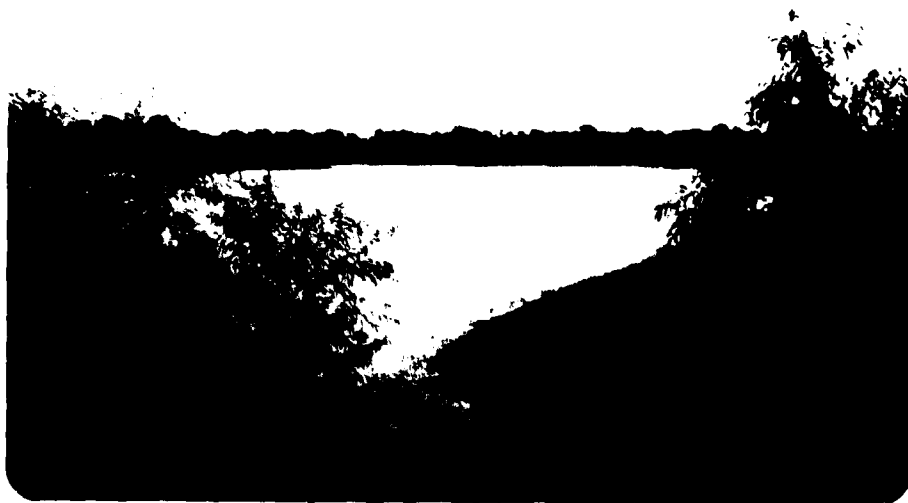
PHOTO NO. 11 - UPSTREAM FROM LEFT END.
